# **Spider Tracks Limited**

#### **TEST REPORT FOR**

Spider 7, Spider 7 Internal Antenna

Tested To The Following Standard(s)/Specification(s): RTCA/DO-160G (2010)

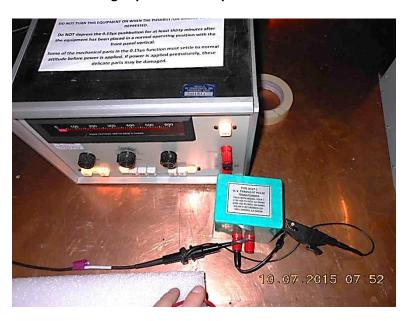
Section 17 – Calibration Setup, Open Circuit

The output of the  $50\Omega$  source impedance voltage spike generator was adjusted to produce the required peak voltage 10uS spikes in accordance with RTCA/DO-160G Section 17 Figure 17-1. The source impedance of the voltage spike generator was verified by placing a  $50\Omega$  load across the output of the generator, and observing that the amplitude was reduced to 50% of the calibration level.

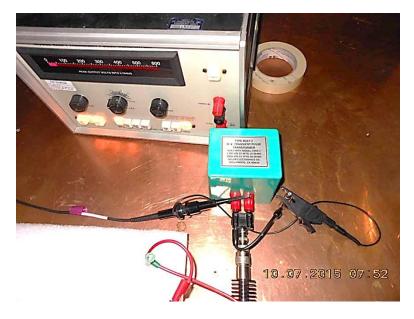
Section 17 – Calibration Setup, 50 Ohm

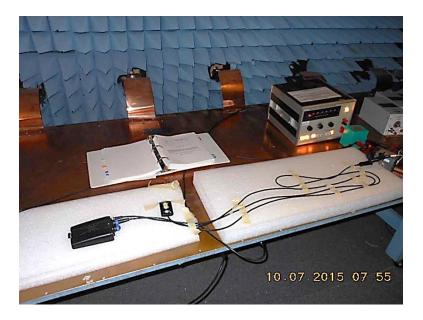
Section 17 – Overall View of Test Setup

The UUT was installed into the circuit by connecting the power lead of the UUT in series with the coupling transformer. One transient pulse per second was injected onto the power lines. After pulses were injected for 1 minute at a minimum rate of 1 pulse per second, the amplitude was reduced and the UUT was turned off. The output of the spike generator was reversed and the test was repeated as described above in negative polarity. The UUT was monitored throughout the testing and its functionality was verified after the testing was completed. Test was repeated for each lead listed in the table below.

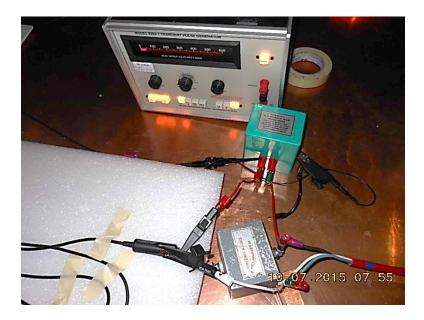
Section 17 –Close-up

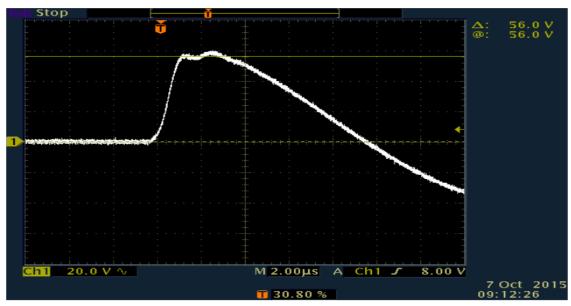
TDS 3052 - 9:21:18 AM 10/7/2015

This waveform capture shows the positive polarity open circuit calibration voltage of the voltage spike transient.

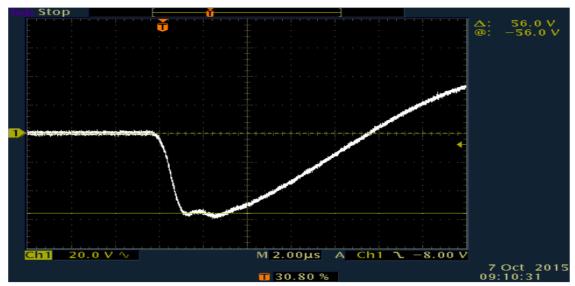
TDS 3052 - 9:19:24 AM 10/7/2015

This waveform capture shows the negative polarity open circuit calibration voltage of the voltage spike transient.

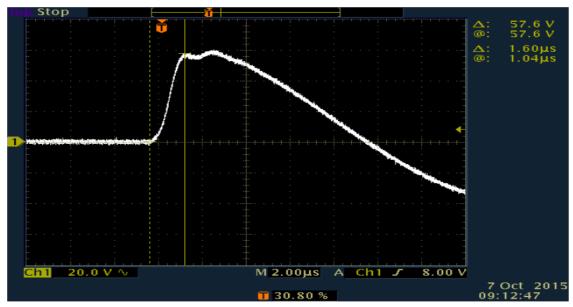
TDS 3052 - 9:21:39 AM 10/7/2015

This waveform capture shows the positive polarity open circuit calibration voltage of the voltage spike transient rise time.

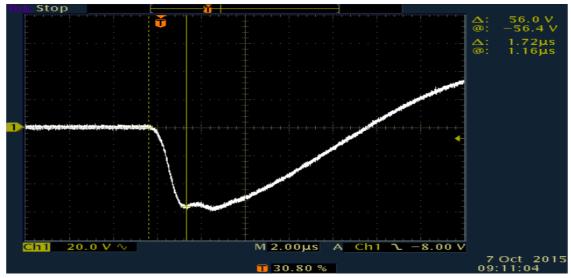
TDS 3052 - 9:19:57 AM 10/7/2015

This waveform capture shows the negative polarity open circuit calibration voltage of the voltage spike transient rise time.

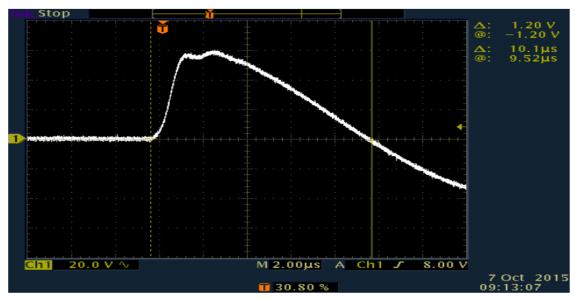
TDS 3052 - 9:21:59 AM 10/7/2015

This waveform capture shows the positive polarity open circuit calibration voltage of the voltage spike transient pulse width.

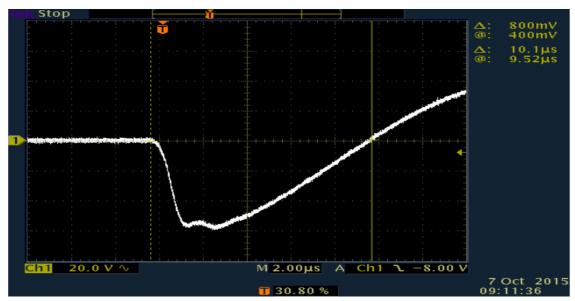
TDS 3052 - 9:20:29 AM 10/7/2015

This waveform capture shows the negative polarity open circuit calibration voltage of the voltage spike transient pulse width.

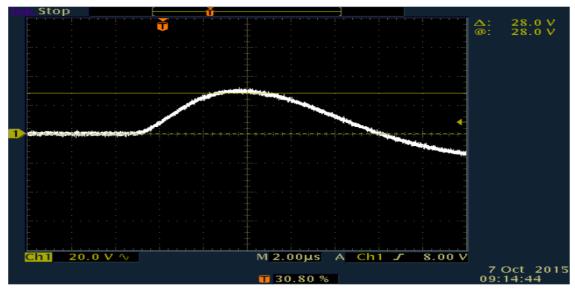
TDS 3052 - 9:23:36 AM 10/7/2015

This waveform capture shows the ½ amplitude positive polarity  $50\Omega$  source impedance calibration voltage of the voltage spike generator with a  $50\Omega$  load across the output terminals of the generator.

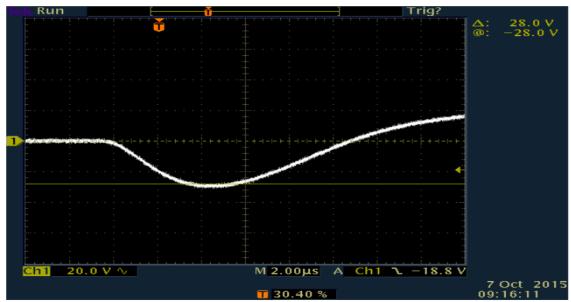
TDS 3052 - 9:25:03 AM 10/7/2015

This waveform capture shows the ½ amplitude negative polarity  $50\Omega$  source impedance calibration voltage of the voltage spike generator with a  $50\Omega$  load across the output terminals of the generator.

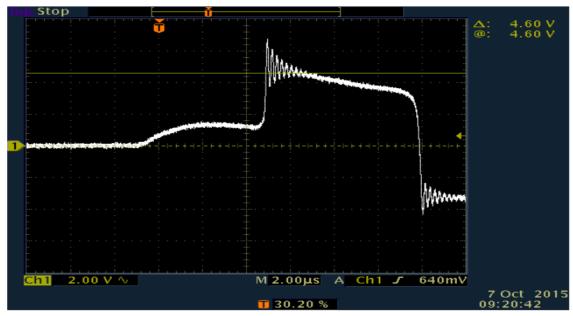
TDS 3052 - 9:29:34 AM 10/7/2015

This waveform capture shows a typical positive polarity voltage spike transient applied to the UUT.

Test Results						
Mode/Config #	Lead Tested	V pk	<b>Pulses Applied</b>	Polarity	Results	Observations
1	+28Vdc	56V	50	Positive	PASS	
1	+28Vdc	56V	50	Negative	PASS

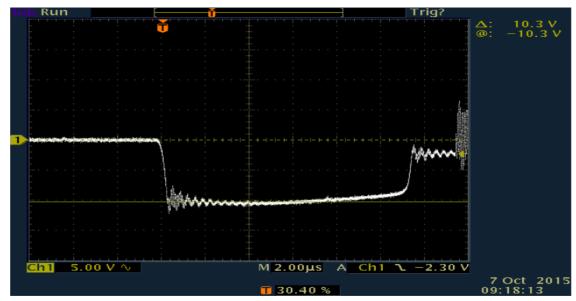
TDS 3052 - 9:27:05 AM 10/7/2015

This waveform capture shows a typical negative polarity voltage spike transient applied to the UUT.
